Forklift Safety > Newsletter

Incident Investigation

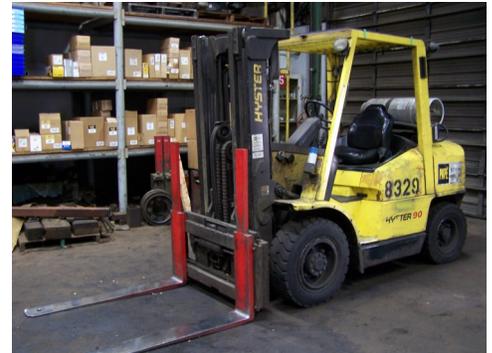
A forklift operator set down a unit of green veneer on some stickers. As the operator started to back out from under the unit the carriage and forks detached from the front of the forklift (Hyster 90).

The top of the forklift carriage (photo on left) hooks onto a raised lip and is held in place by the weight of the carriage resting on this lip on the top and two brackets on the bottom (photo below right). However, both brackets in this incident were loose. Since the chain was over stretched, when the forks were lowered the heels would strike the ground essentially pushing the carriage up and contributing to the carriage coming off the raised lip.

- 1) Train forklift operators how to inspect chains and forks.
- 2) Replace over stretched chains on forklifts.
- 3) Secure forklift carriage clamping brackets using Loctite, top lock nuts, flat washer, and grade 8 bolts.
- 4) Inspect clamping brackets during routine forklift maintenance.
- 5) Adjust the heel of the fork to 1/4" above the ground. It should not rest on the ground or it will increase fork wear.
